Fieldcrest Community Unit School District 6

Re: Fieldcrest Middle School Wall

This is a supplemental report to the one Farnsworth Group provided dated January 14, 2019, which is attached for reference. In that report we recommended additional field investigation which required better access to the exterior walls and the roof framing from the interior. This report provides our conclusions and recommendations following that investigation which occurred on April 5, 2019. Paige Dodson and Michael Bryant were on site for this.

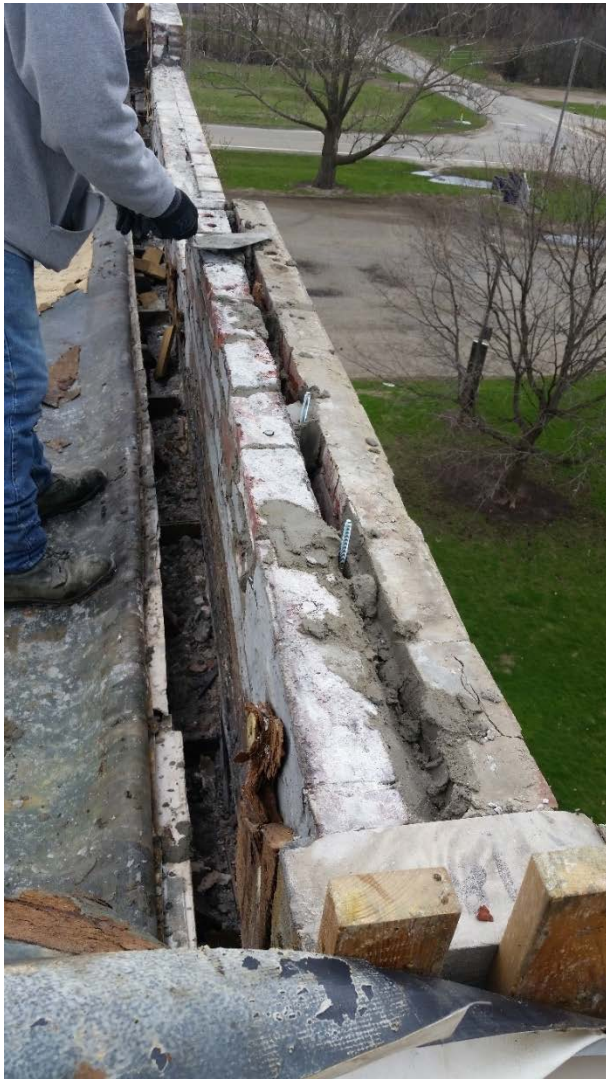
View of south parapet wall from 2016 showing the parapet construction

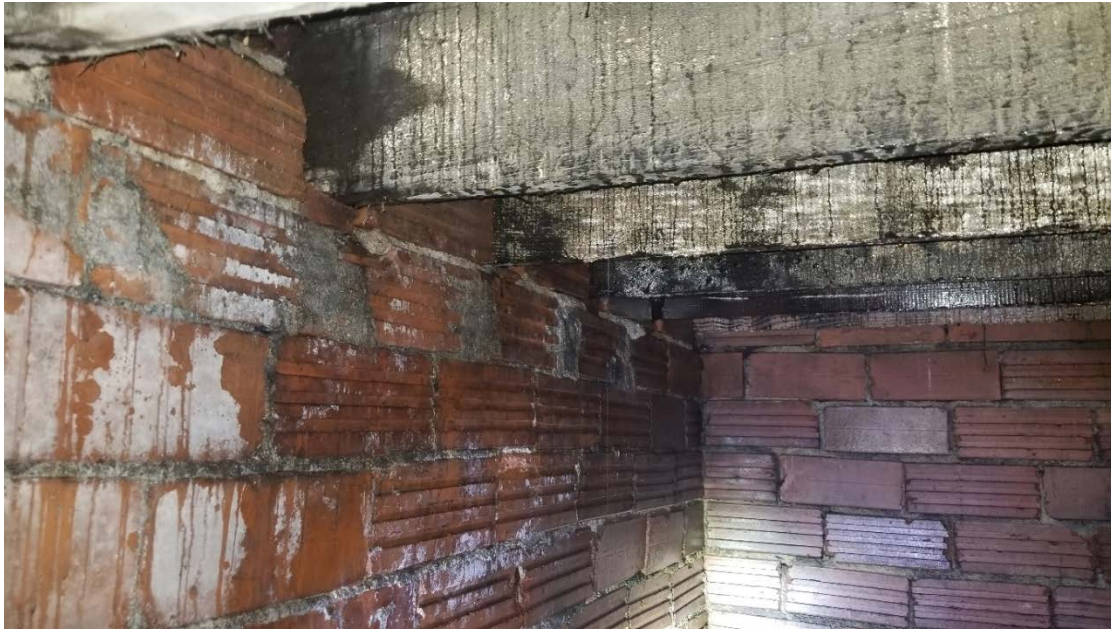
View from inside attic space of northeast corner showing joist bearing on clay tile wall

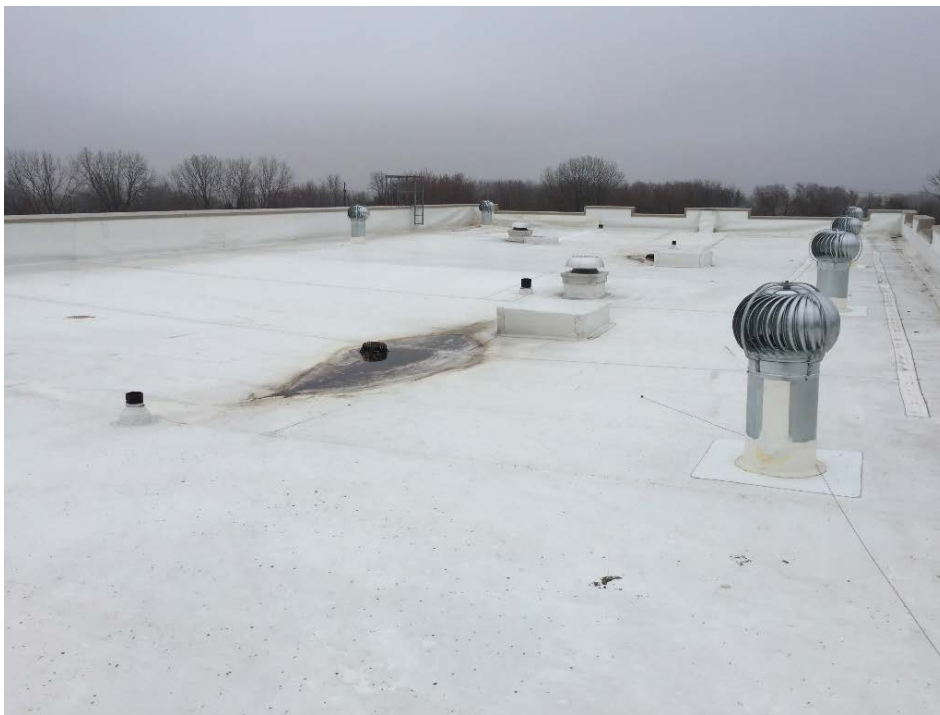
Overall view of roof

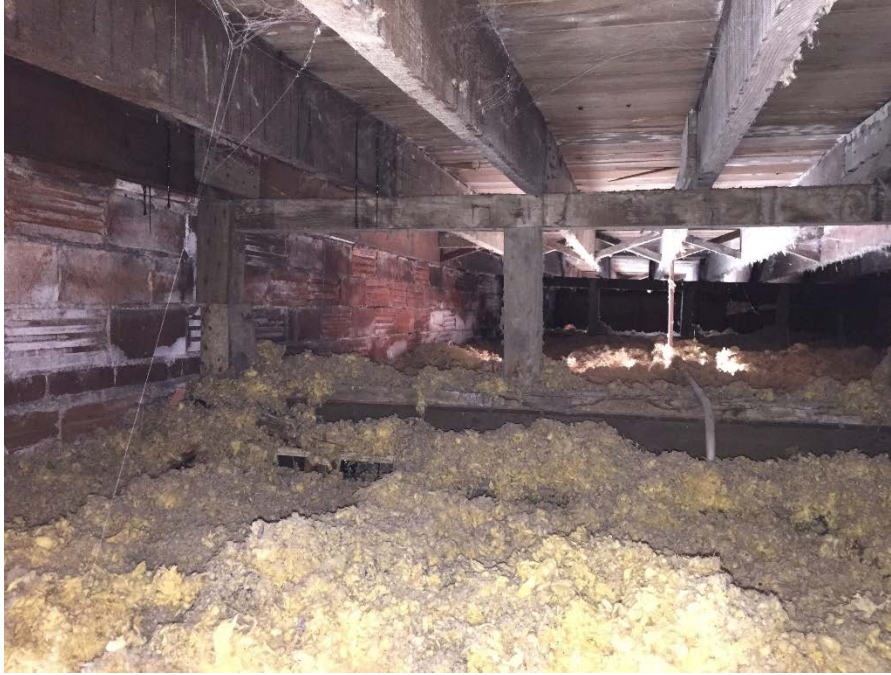
View of roof structure and wood construction on top of steel beam
